# DRIVING PUMP RELIABILITY FORWARD WITH ADVANCED COMPOSITE WEAR RINGS

## ABSTRACT

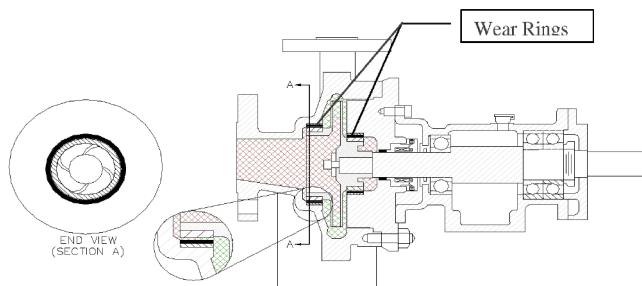
Figure 1. Composite Components in a Horizontal Pump. (Courtesy, [http://www2.dupont.com/Vespel/en\\_US/Literature/crfam.pdf](http://www2.dupont.com/Vespel/en_US/Literature/crfam.pdf))

Stationary pump wear rings, throat bushings, interstage bushings, pressure reducing bushings, and vertical pump line shaft bearings and bowl bushings were converted from metal to the composite. Figure 1 shows the location of composite components in a typical horizontal pump. Figure 2 shows the location of composite components in a typical vertical pump.

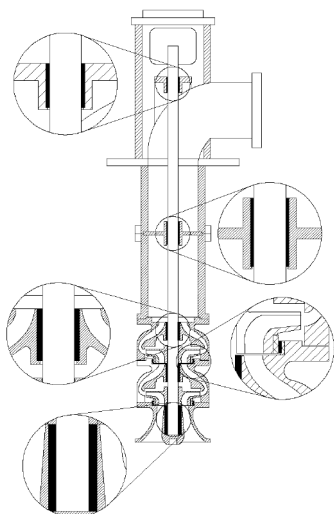
Figure 2: Composite Components in a Vertical Pump.

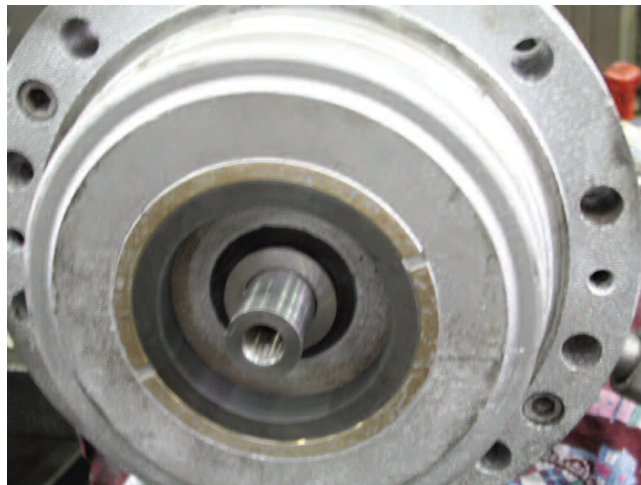
Figure 3. Solid Composite Wear Ring.

Most pump repairs were completed by the onsite refinery maintenance facility using the following procedures. Composite components were machined and installed with an interference fit. Some applications used the composite as a solid component (Figure 3), other applications used the composite as an insert into the existing metal wear ring, which was machined and used as a holder (Figure 4). In either case, additional anti-rotation devices such as pins or screws were not used—the interference fit providing the sole anti-rotation mechanism. This method has proved effective. Existing metal rotating components were run against the composite stationary components with no special machining or hardness requirements.

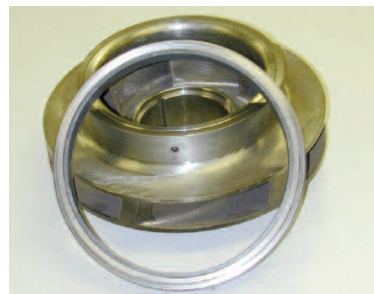
Figure 4. Composite Insert Wear Ring.

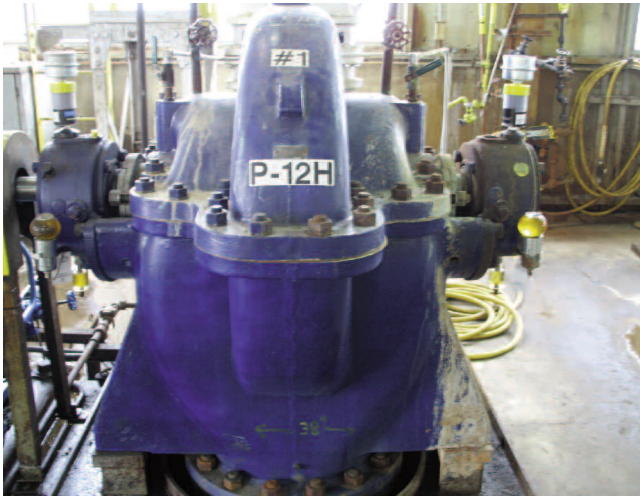
Figure 5. Between Bearings Pump with Composite Wear Rings Installed.

- Temperatures from 65°F (18°C) to 475°F (246°C)
- Services included ethane, propane, gasoline, boiler feed water, furnace oil, kerosene, diethanolamine (DEA), cumene, sulfuric acid, caustic, naphtha, and sour water
- Thirty-six vertical pumps and 25 horizontal pumps, with power ranges from 25 horsepower to 750 horsepower
- API pump types single-stage overhung (OH2), vertical inline (OH4), between bearings double-suction (BB1) as shown in Figure 5, between bearings horizontally split multistage (BB3), and multistage vertical (VS6)

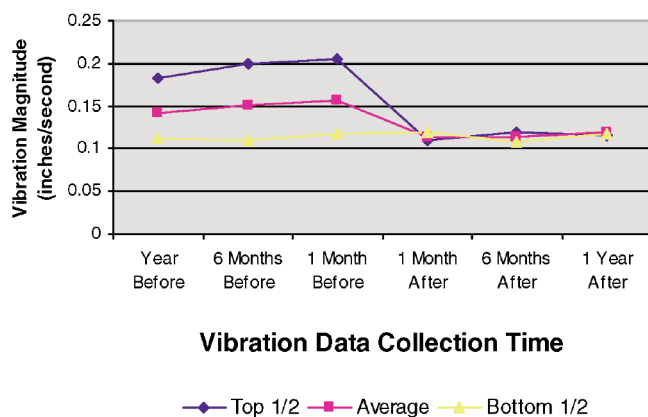
Figure 6. Vibration Magnitude Before and After Composite Installation.

frequencies. Therefore, the data needed to be simplified. First, vibration frequency was ignored and only overall velocity readings were used for each data point. Next, the average of the individual overall readings for a pump was used as the vibration magnitude for any point in time—an overall of overalls. (Example: if an overhung horizontal pump had three data collection points, with horizontal, vertical, and axial overall vibration readings of 0.12, 0.18, and 0.20 inches per second (ips), the “overall” reading at that point in time would be the average of these three overalls, or 0.17.) Vibration readings were only used for horizontal pumps, due to data collection points being directly on the pump rotor (refer to *Note on Vertical Pumps* below). Sufficient data were available for a total of 24 pumps, with results shown in Figure 6.

The results show an average reduction of 25 percent in overall vibration levels for the subject population from 0.15 to 0.11 ips. The impact of composites was evaluated by dividing the data set into two groups, the “Top ½” of pumps showing the largest improvement and the “Bottom ½” of pumps showing little or no vibration reduction. We find that the top half of pumps were previously running with higher vibration amplitudes (>0.15 ips), and experienced an average vibration reduction of 42 percent. For the bottom half of pumps, which were already running at very low vibration (close to 0.1 ips), reducing the clearance with composites had no impact on vibration.

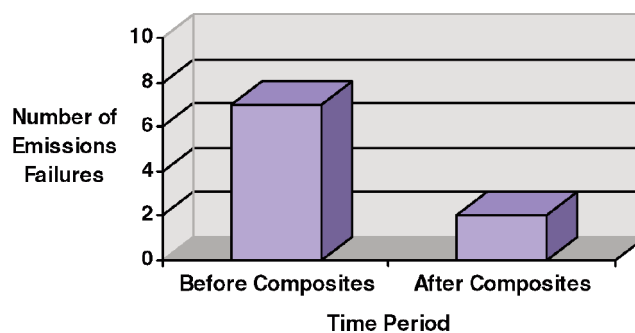
Figure 7. Emissions Failures Before and After Composite Installation.

The impact of composites was evaluated by counting emissions failures during the equivalent run-time before and after conversion to composite wear rings. For the 12 pumps with single seals, there was a total of 14.2 years of run-time with composites. Figure 7 shows the number of emissions failures before and after the composite program. During the period prior to composite installation, there were seven emissions failures; after composites, there were two emissions failures—a 70 percent reduction in emissions failure rate.
